**Inspection Report**  
**Minerals Regulatory Program**  
November 1, 2005

**Mine Name:** Highland Mist  
**Operator Name:** Anasazi Gold Reserves  
c/o North American Exploration  
447 North 300 West Suite 3  
Kaysville, Utah 84037-4203

**Permit number:** S/021/035  
**Inspection Date:** October 28, 2005  
**Time:** 8:30 AM

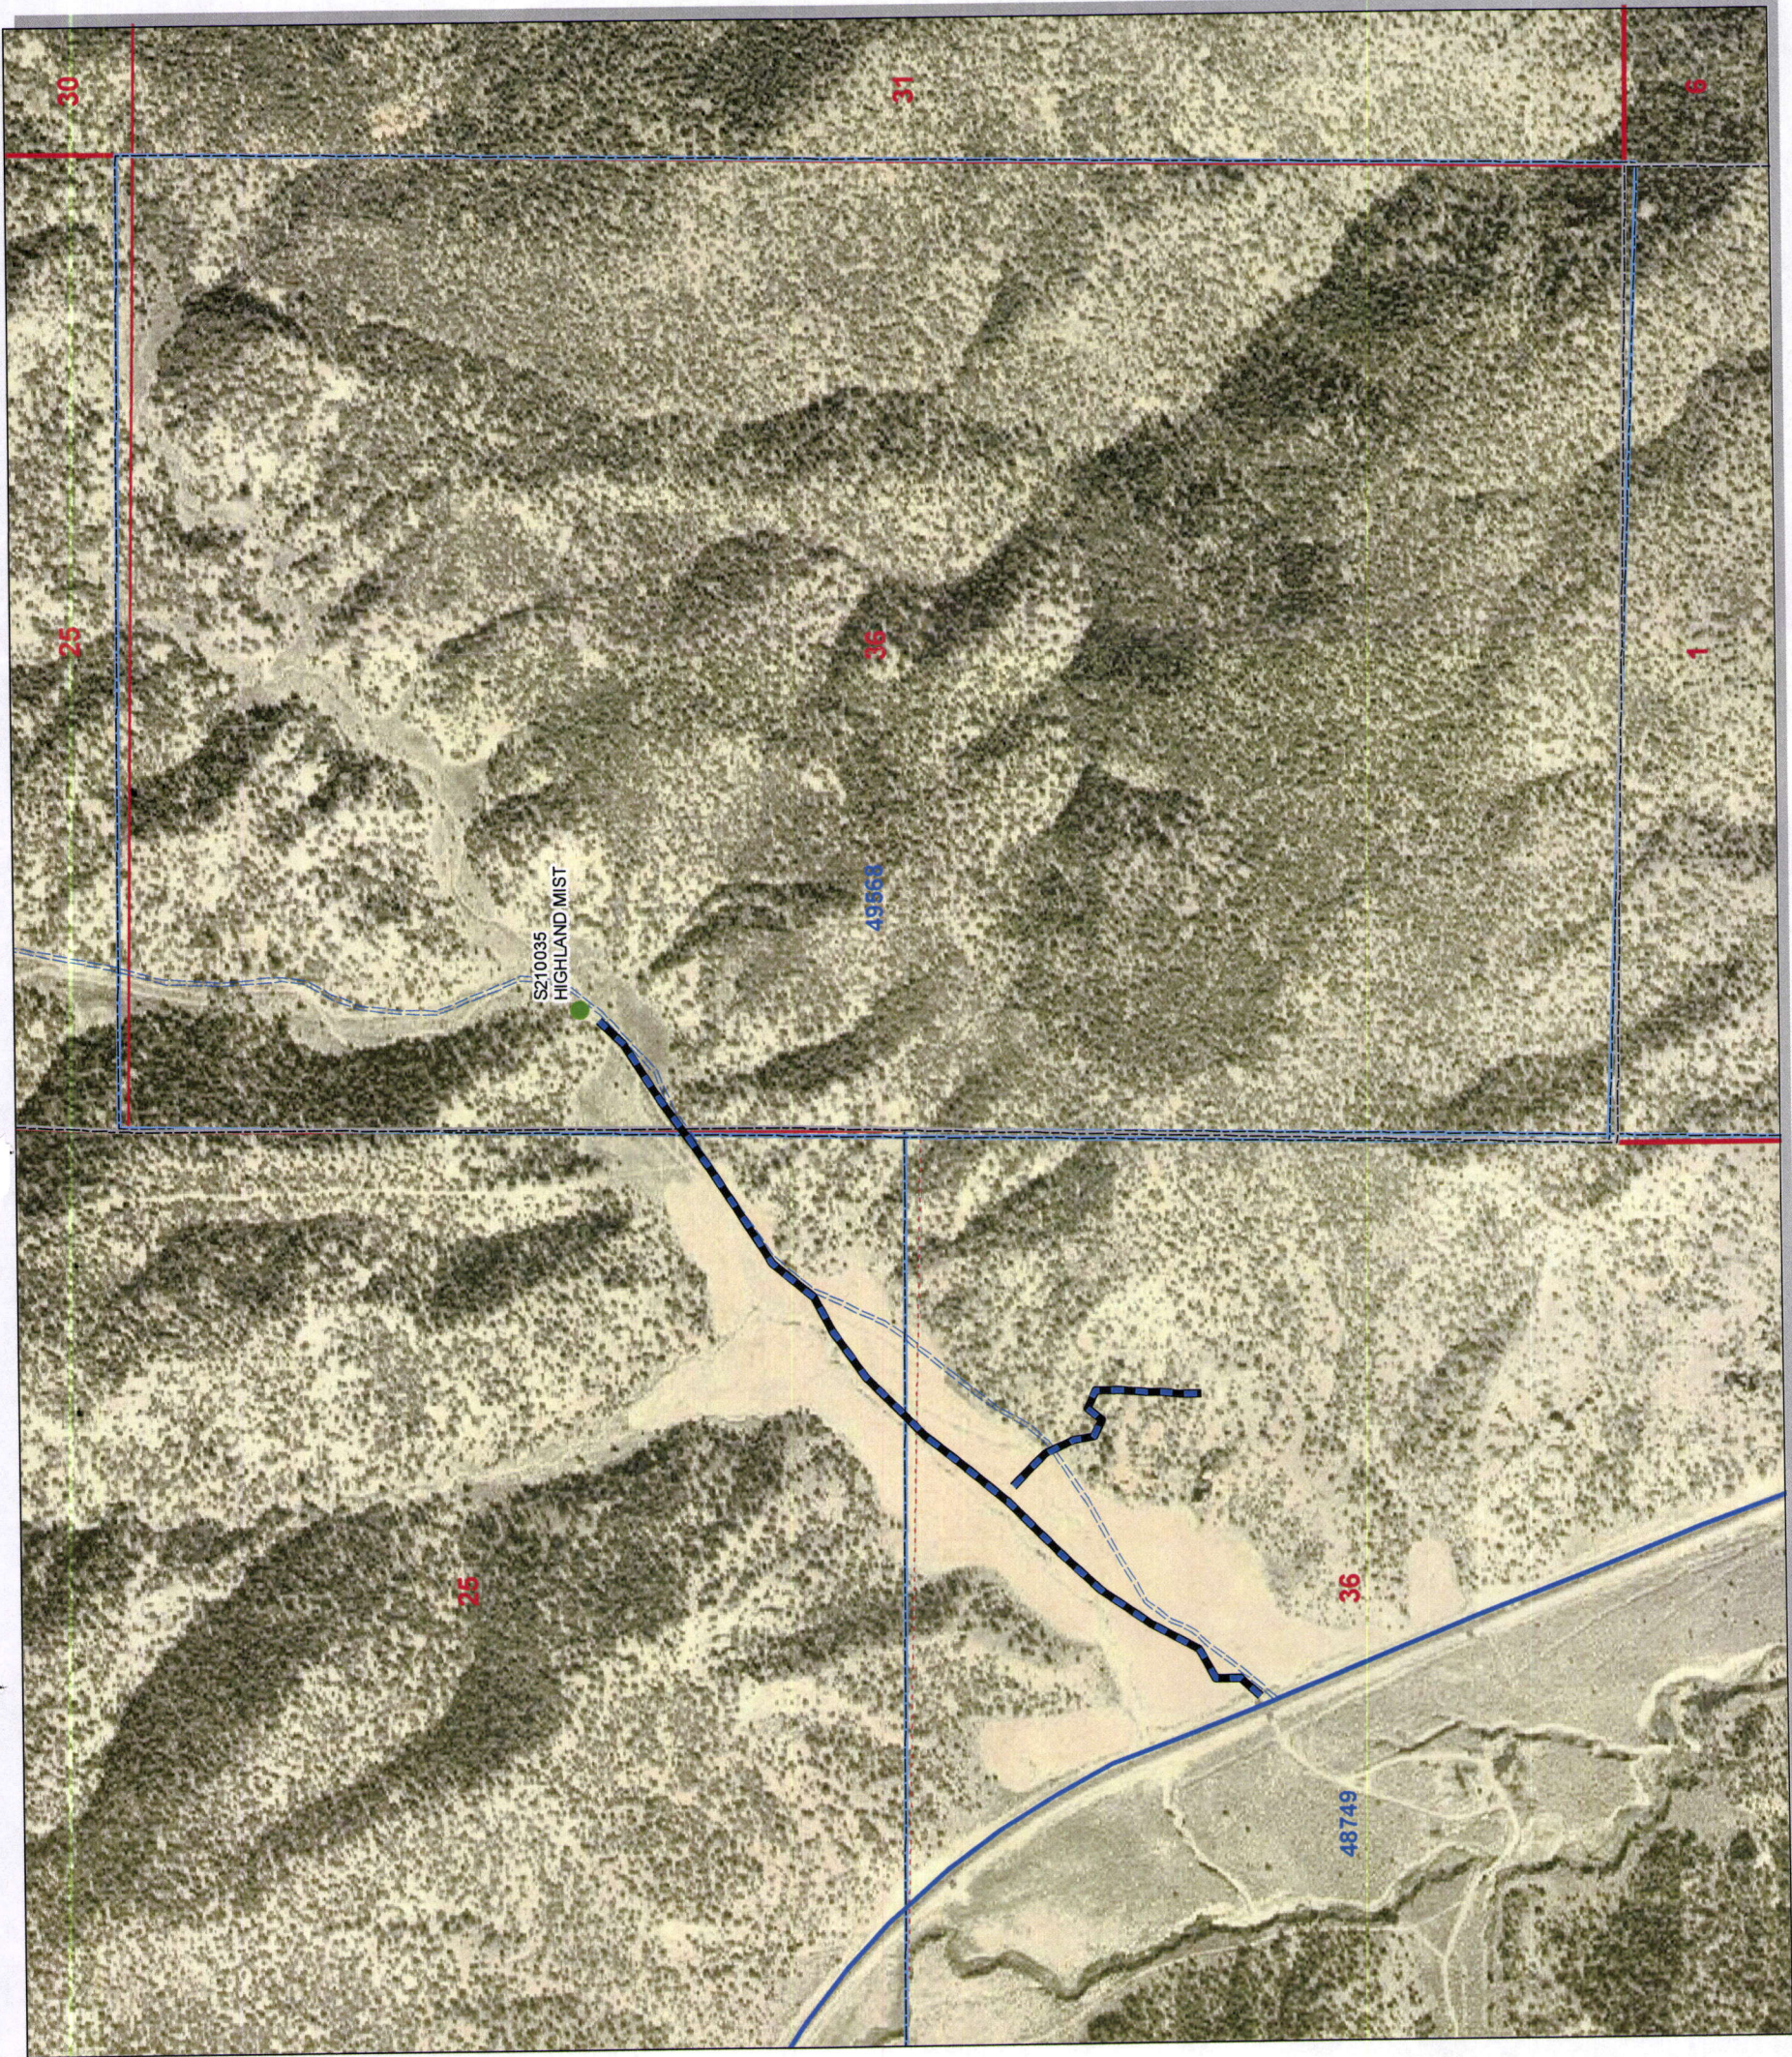
A GPS map was made of the road disturbances was made while I was onsite.
